ASTM PHASE I ENVIRONMENTAL SITE ASSESSMENT FORSTER MANUFACTURING 81 DEPOT STREET WILTON, MAINE REVISION 1

Ransom Consulting, Inc.

> Project 131.06099.005 June 29, 2015

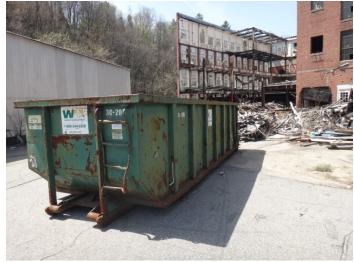
Photo 5: Dumpster observed in eastern portion of the Site. View is to the west. This dumpster has reportedly been removed as of the date of this report.

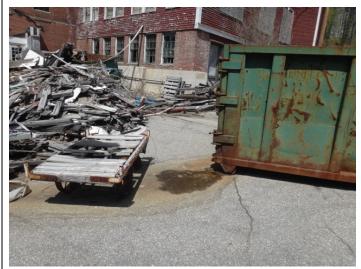
Photo 7: The dumpster in the eastern portion of the Site was observed to be leaking (likely accumulated rainwater).

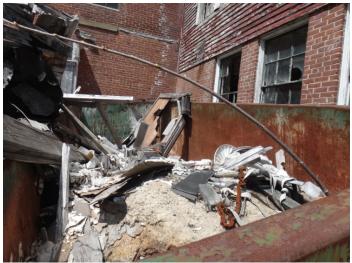
Photo 9: Construction and demolition debris observed in loading dock dumpster.

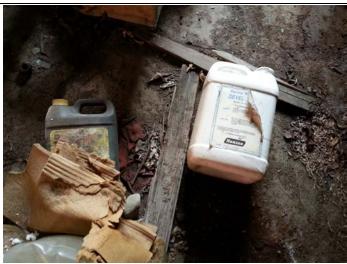
Photo 14: Containers (some of which were partially full) of "developer" and unknown liquids were observed in the photo shed.

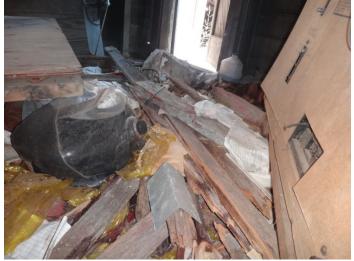
Photo 15: Unlabeled containers of liquid observed in the photo shed.

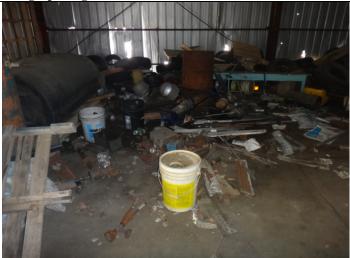
Photo 53: Debris, containers (some of which were partially full of unknown liquids), and drums were observed inside the metal storage building.

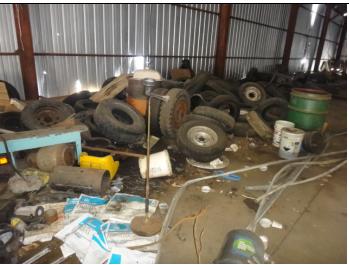
Photo 54: Tires, debris, containers (some of which were partially full of unknown liquids), and drums were observed inside the metal storage building.

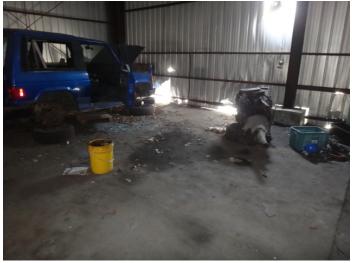
Photo 55: Junk vehicles, containers containing unknown liquids and oily staining observed inside the metal storage building.

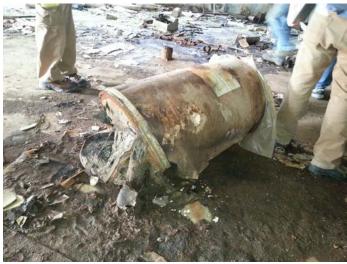
Photo 61: Ruptured drum observed in the eastern portion of the Site building basement (former printing room).

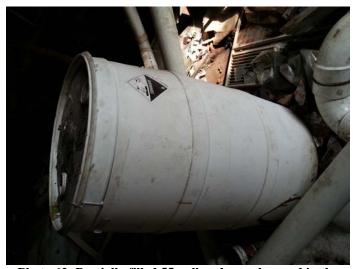
Photo 62: Partially filled 55-gallon drum observed in the eastern portion of the Site building basement (former printing room).

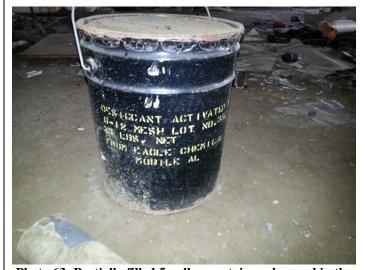
Photo 63: Partially filled 5-gallon container observed in the eastern portion of the Site building basement (former printing room).

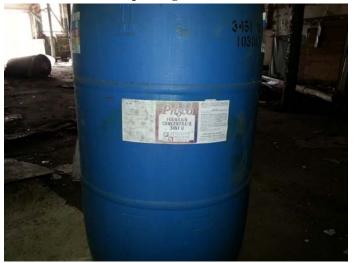
Photo 64: Partially filled 55-gallon drum observed in the eastern portion of the Site building basement (former printing room).

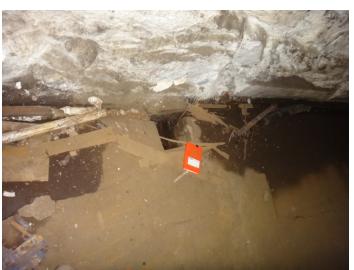
Photo 66: Trench floor drains were observed to run along the northern and southern sides of interior basement rooms. These trench drains discharged into sub-surface drains.

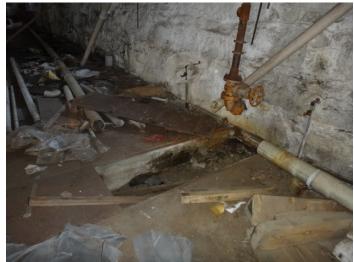
Photo 67: Another view of trench drains discharging to a common sub-surface drain.

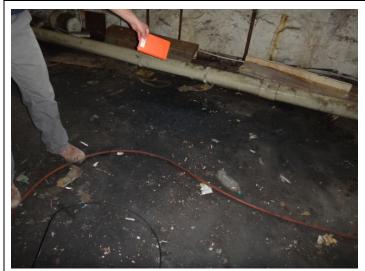
Photo 69: Oil-stained floors observed in the eastern portion of the Site building basement (former printing room).

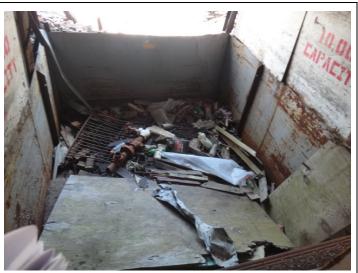
Photo 70: Evidence of dumping in the elevator sump in the basement of the Site building.

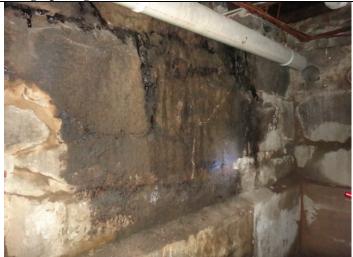
Photo 75: Area of significant oil staining on walls in the central portion of the Site building basement (former manufacturing area).

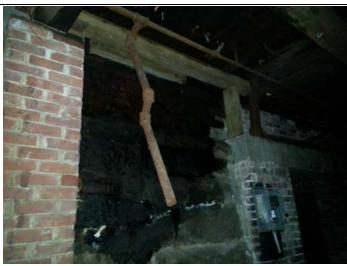
Photo 76: Second area of significant oil staining on walls in the central portion of the Site building basement (former manufacturing area).

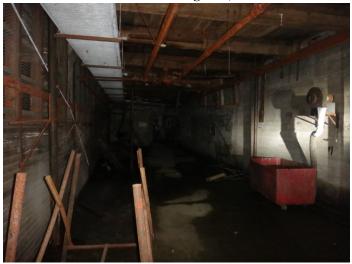
Photo 77: Hallway in the eastern portion of the Site building basement. Piping along the concrete wall to the right is capped fill and vent pipes for a former oil storage tank.

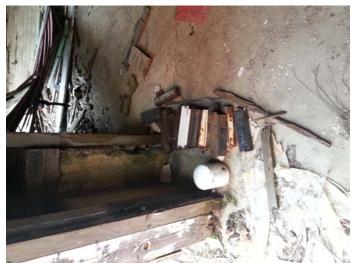
Photo 84: Fluorescent light ballasts observed in the former machine shop area in the northeastern portion of the Site building basement.

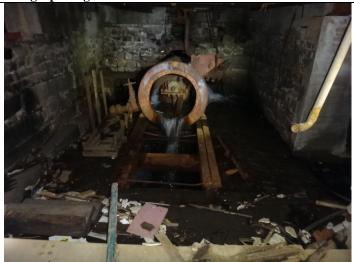
Photo 85: Turbine located in the northeastern portion of the basement of the Site Building. Evidence of dumping in the open water surrounding the turbine.

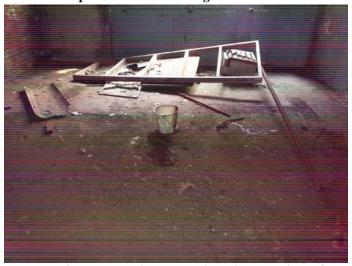
Photo 87: Floor drain and partially-full container of unknown liquid observed in the former tool room in the Site building basement.

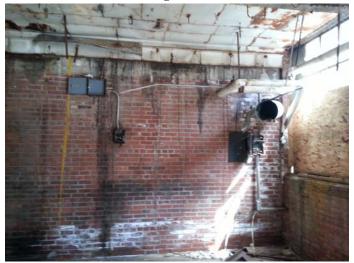
Photo 89: Oily staining observed on the floors and walls of rooms in the central/northern portion of the Site building basement.

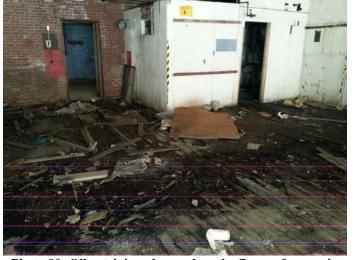
Photo 90: Oily staining observed on the floors of rooms in the central/northern portion of the Site building basement.

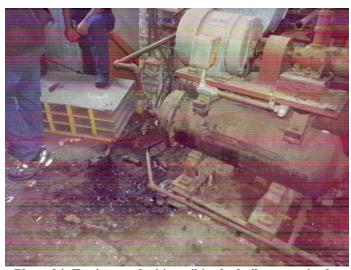
Photo 94: Equipment leaking oil in the boiler room in the eastern portion of the Site building basement.

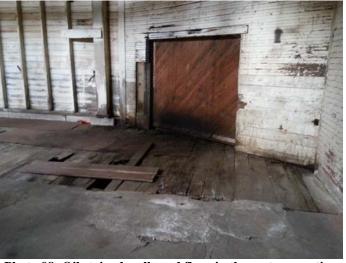
Photo 98: Oil stained walls and floor in the eastern portion of the first floor of the Site building.

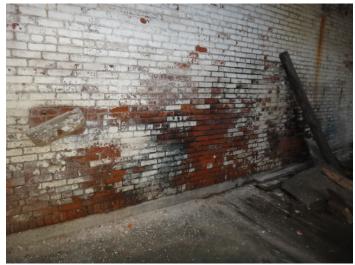
Photo 99: Oil stained walls in the eastern portion of the first floor of the Site building.

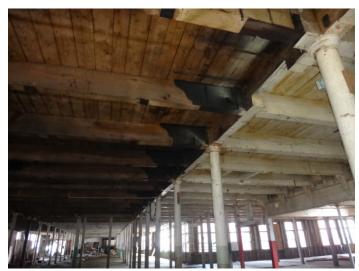
Photo 100: Black staining on ceiling of the first floor of the Site building.

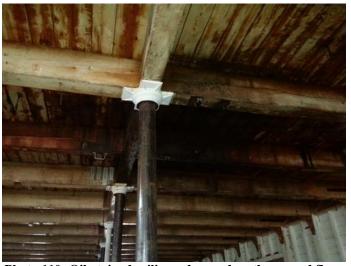
Photo 110: Oil-stained ceilings observed on the second floor of the Site building.

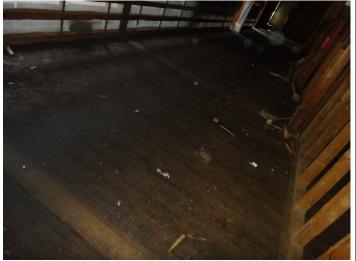
Photo 121: Black staining on the floor of the storage area in the eastern portion of the third floor of the Site building.
